X-Ray Results for AES-008

This document shows the x-ray results for the helium vessel #9 that became part of dressed cavity AES-008.

X-RAY READER SHEET

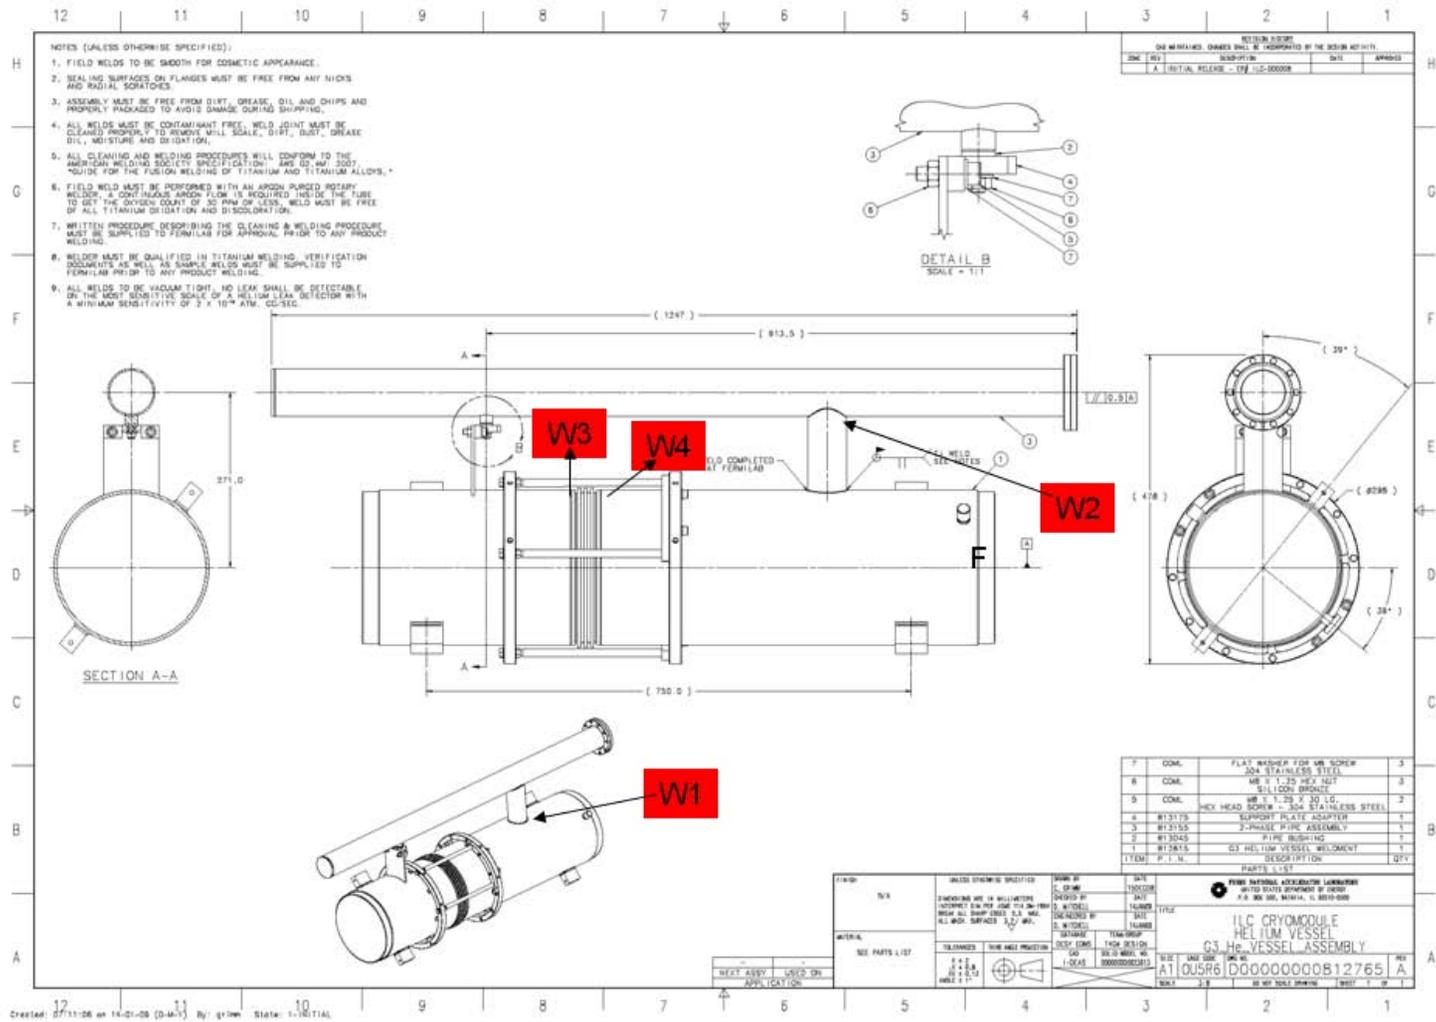
X-RAY SERIAL NUMBER	Accept	Non-Conforming	Cracks	Shrinkage	Shrink Cavities	Porosity	Gas Holes	Voils	Surface	REMARKS OR OTHER DISCONTINUITIES
9-W1 A-B	X									
B-C	X									
C-D	X									
D-A		X								INCOMPLETE FUSION
9-W2 A-B	X									
B-C	X					X				
C-D	X									
D-A	X									
9-W3 A-B	X									
B-C	X									
C-D	X									
D-E	X									
E-F	X									
F-G	X									
G-H	X					X				
H-A	X									
9-W4 A-B	X									
B-C	X									
C-D	X									
D-E	X					X				
E-F	X					X				
F-G	X					X				
G-H	X					X				
H-A	X					X

This map identifies the names and locations of the welds that were x-rayed.
