H-disease in TESLA cavities

Hydrogen Disease in SC Cavities
„Q-disease“

H-disease test with 9-cell EP cavities

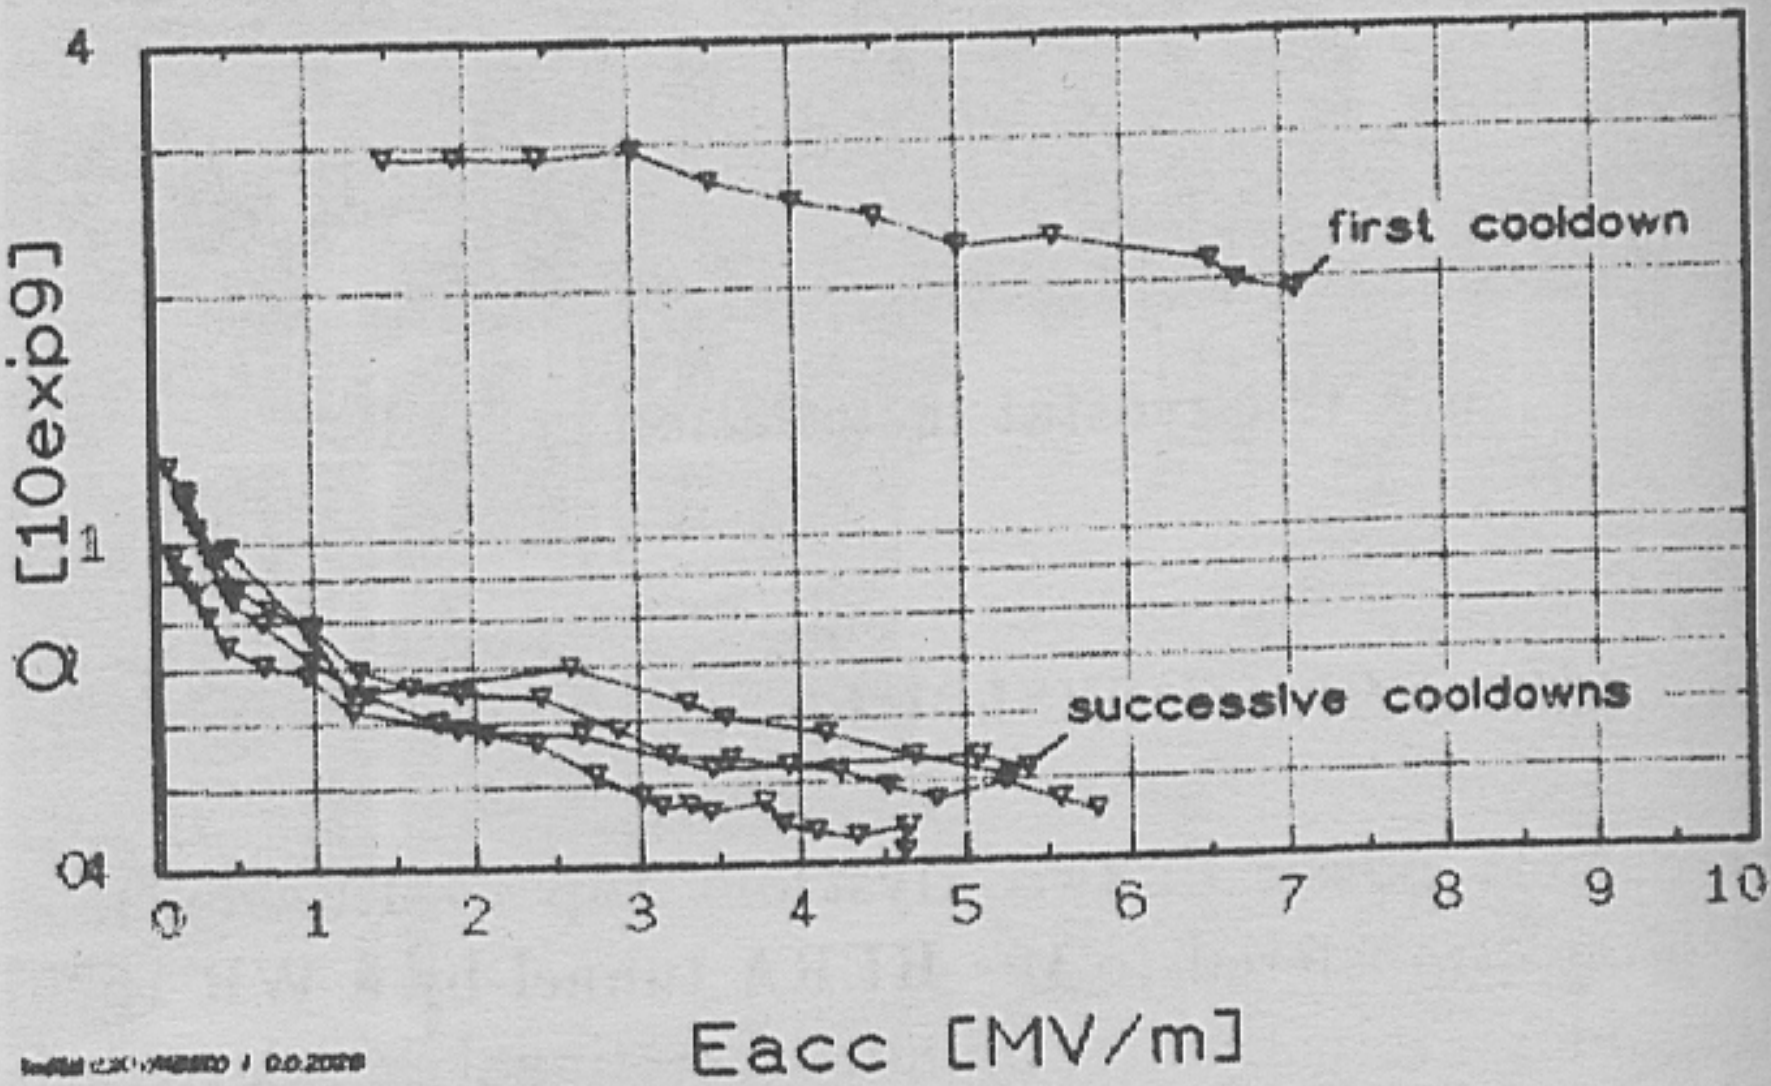
Figure 1: Q degradation after several cooldowns

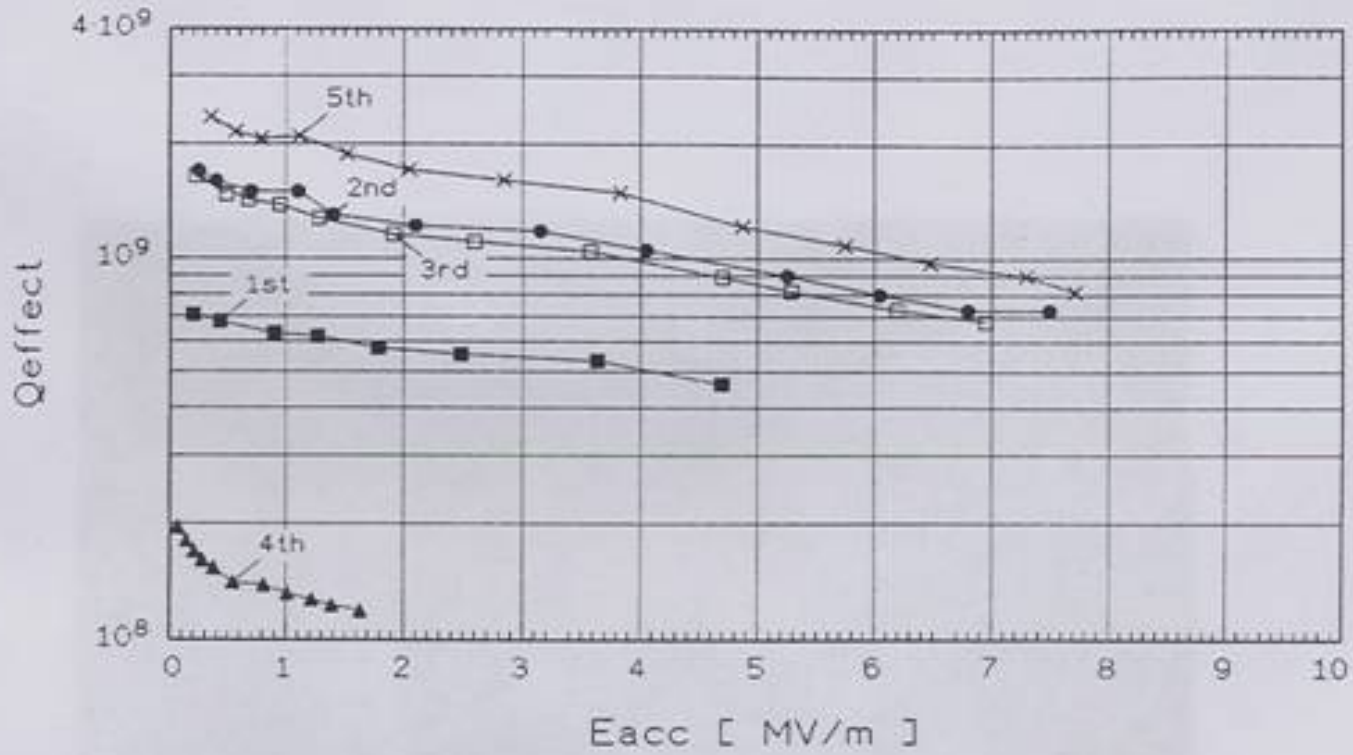
Fig. 3: Measured Q vs E_{acc} curves for different cooldown conditions
1st: continous cooldown from 300 K to 4.2 K in 24 h
2nd (3rd, 4th, 5th): stop during cooldown at 180 K (150 K, 100 K, 150 K) for 20 h; afterwards fast cooldown to 4.2 K in about 1.5 h (1.8 h, 1.5 h, 1.3 h)

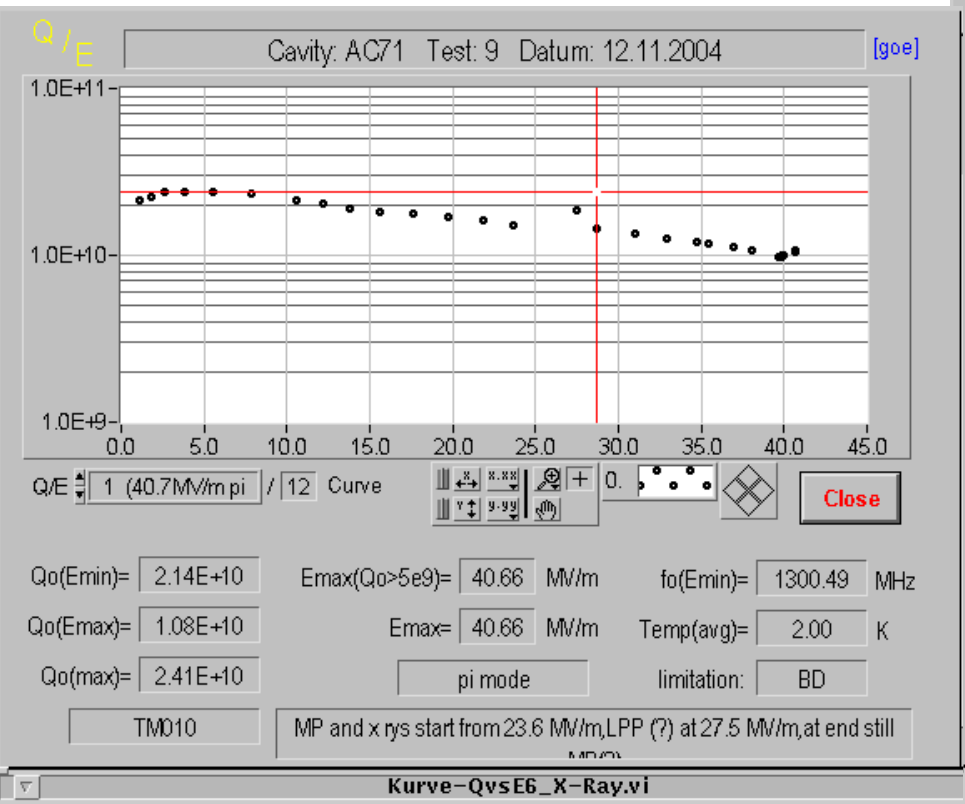
Q / E
Cavity: AC71 Test: 9 Datum: 12.11.2004
[goe]
1.0E+11
1.0E+10
1.0E+9
0.0 5.0 10.0 15.0 20.0 25.0 30.0 35.0 40.0 45.0
Q/E 1 (40.7MV/m pi / 12 Curve
Close
Qo(Emin)= 2.14E+10
Emax(Qo>5e9)= 40.66 MV/m
fo(Emin)= 1300.49 MHz
Qo(Emax)= 1.08E+10
Emax= 40.66 MV/m
Temp(avg)= 2.00 K
Qo(max)= 2.41E+10
pi mode
limitation: BD
TM010
MP and x rys start from 23.6 MV/m,LPP (?) at 27.5 MV/m,at end still
Kurve-QvsE6_X-Ray.vi

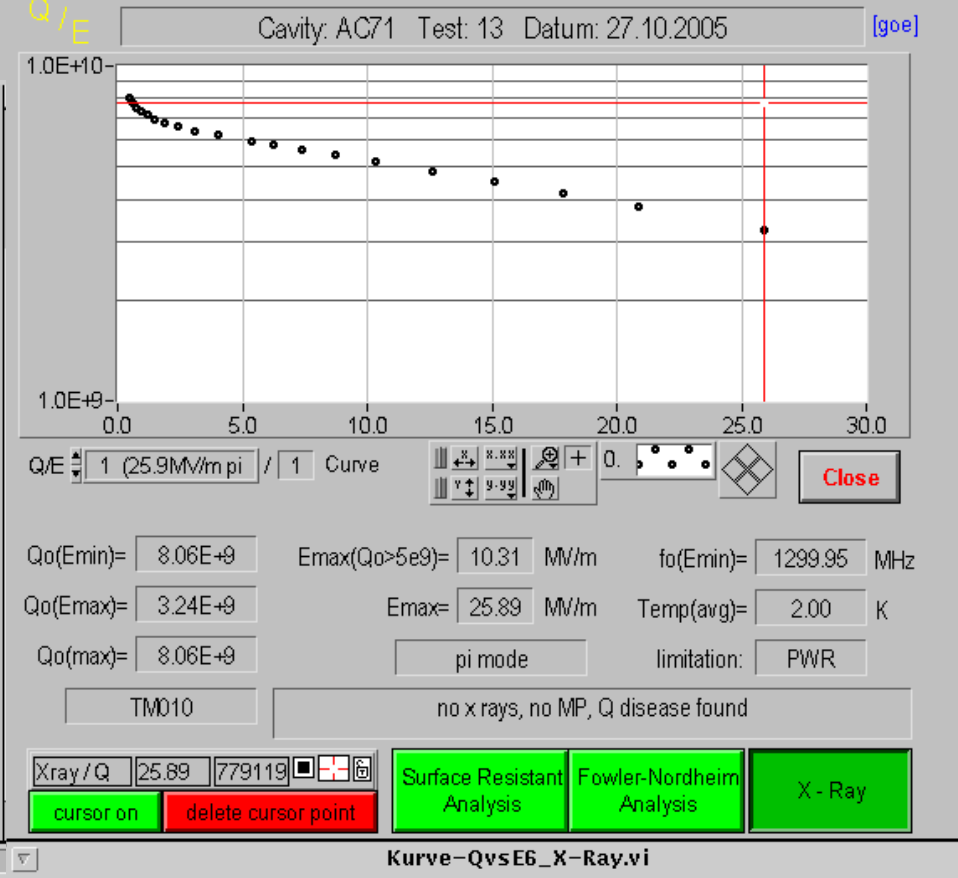
Q / E
Cavity: AC71 Test: 13 Datum: 27.10.2005
[goe]
1.0E+10
1.0E+9
0.0 5.0 10.0 15.0 20.0 25.0 30.0
Q/E 1 (25.9MV/m pi / 1 Curve
Close
Qo(Emin)= 8.06E+9
Emax(Qo>5e9)= 10.31 MV/m
fo(Emin)= 1299.95 MHz
Qo(Emax)= 3.24E+9
Emax= 25.89 MV/m
Temp(avg)= 2.00 K
Qo(max)= 8.06E+9
pi mode
limitation: PWR
TM010
no x rays, no MP, Q disease found
Xray / Q 25.89 779119
cursor on
delete cursor point
Surface Resistant Analysis
Fowler-Nordheim Analysis
X - Ray
Kurve-QvsE6_X-Ray.vi

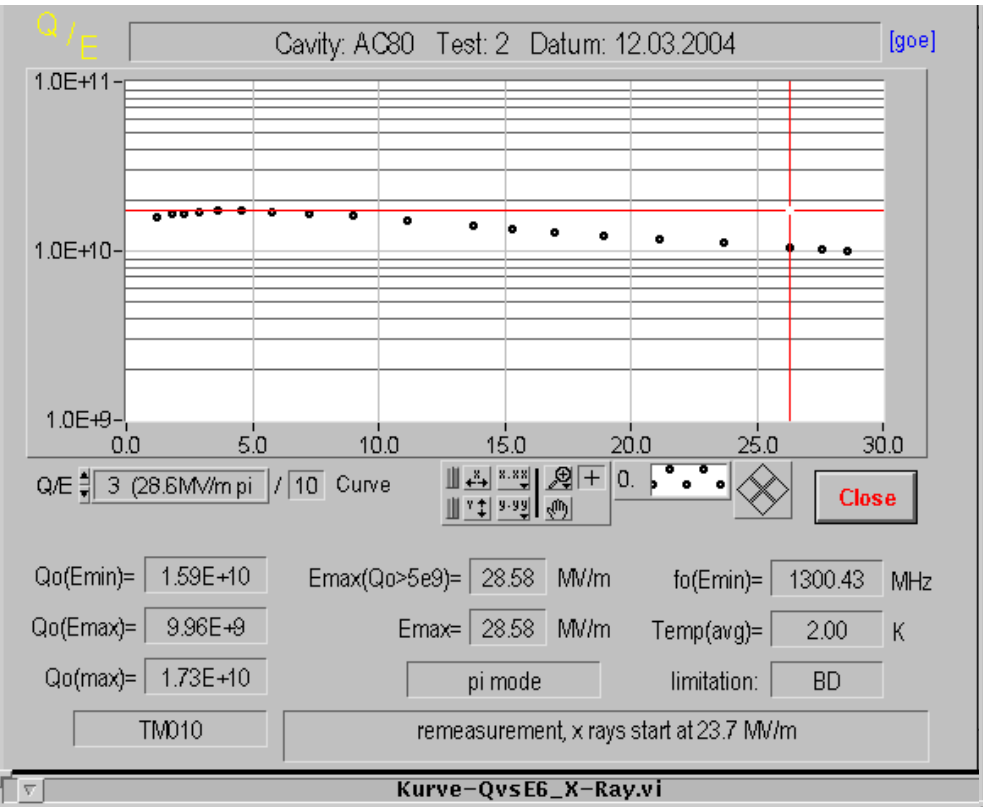
Q / E
Cavity: AC80 Test: 2 Datum: 12.03.2004
[goe]
1.0E+11
1.0E+10
1.0E+9
0.0
5.0
10.0
15.0
20.0
25.0
30.0
Q/E 3 (28.6MV/m pi / 10 Curve
Close
Qo(Emin)= 1.59E+10
Emax(Qo>5e9)= 28.58 MV/m
fo(Emin)= 1300.43 MHz
Qo(Emax)= 9.96E+9
Emax= 28.58 MV/m
Temp(avg)= 2.00 K
Qo(max)= 1.73E+10
pi mode
limitation: BD
TM010
remeasurement, x rays start at 23.7 MV/m
Kurve-QvsE6_X-Ray.vi

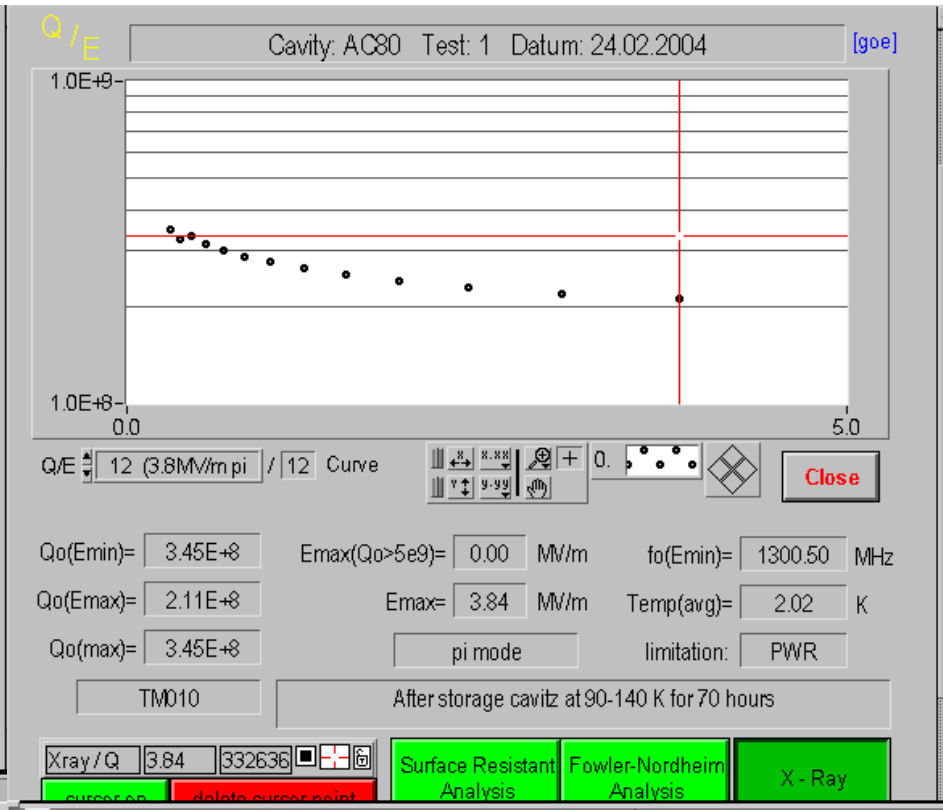
Q / E
Cavity: AC80 Test: 1 Datum: 24.02.2004
[goe]
1.0E+9
1.0E+8
0.0
5.0
Q/E 12 (3.8MV/m pi / 12 Curve
Close
Qo(Emin)= 3.45E+8
Emax(Qo>5e9)= 0.00 MV/m
fo(Emin)= 1300.50 MHz
Qo(Emax)= 2.11E+8
Emax= 3.84 MV/m
Temp(avg)= 2.02 K
Qo(max)= 3.45E+8
pi mode
limitation: PWR
TM010
After storage cavitz at 90-140 K for 70 hours
Xray / Q 3.84 332636
Surface Resistant Analysis
Fowler-Nordheim Analysis
X - Ray
Kurve-QvsE6_X-Ray.vi

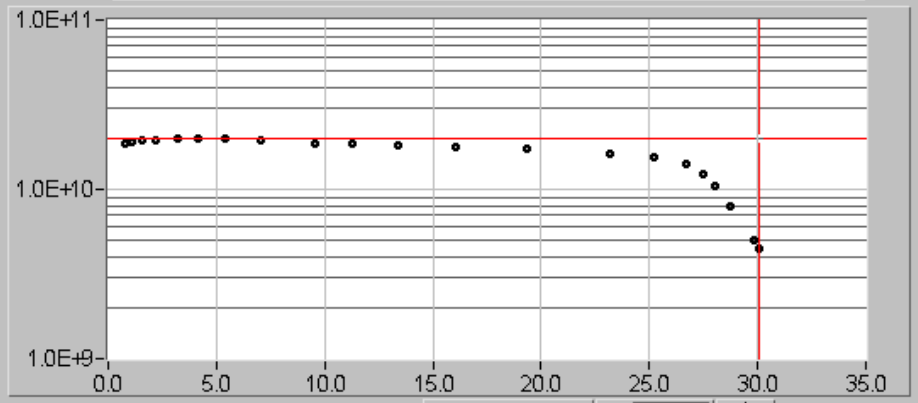
Cavity: Z82 Test: 6 Datum: 25.11.2005 [goe]

no Q disease seen now, no x rays, but Q slope above 25/m observed

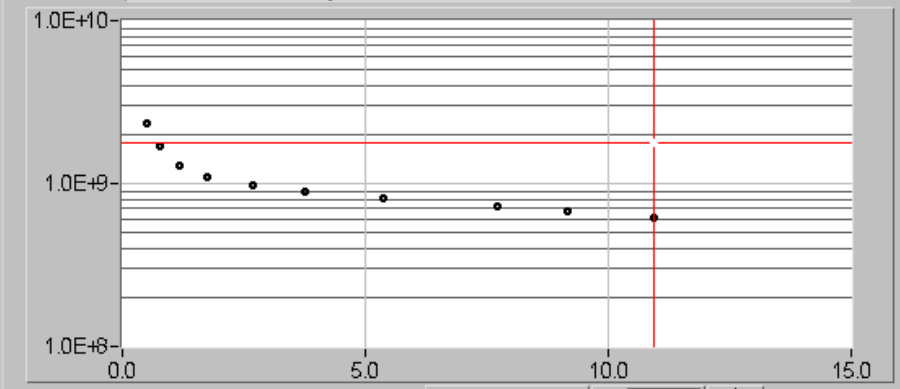
Cavity: Z82 Test: 5 Datum: 24.11.2005 [goe]

strong Q disease seen, no x rays

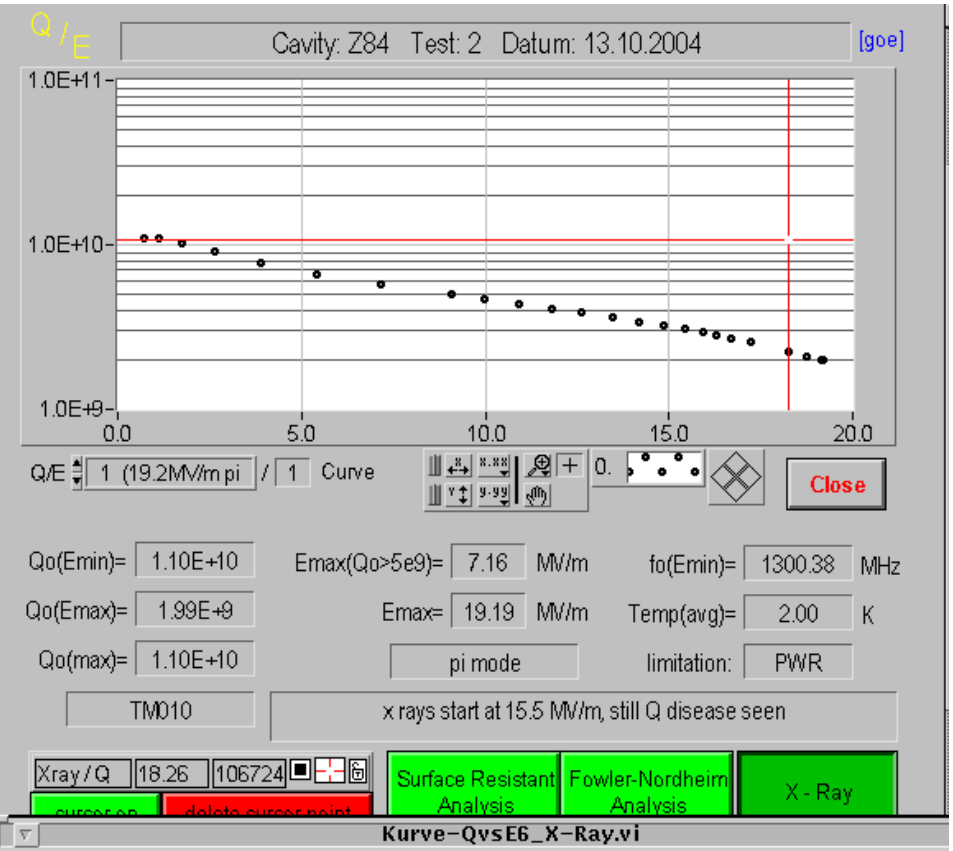
Q / E
Cavity: Z84 Test: 2 Datum: 13.10.2004
[goe]
1.0E+11
1.0E+10
1.0E+9
0.0
5.0
10.0
15.0
20.0
Q/E 1 (19.2MV/m pi / 1 Curve
Close
Qo(Emin)= 1.10E+10
Emax(Qo>5e9)= 7.16 MV/m
fo(Emin)= 1300.38 MHz
Qo(Emax)= 1.99E+9
Emax= 19.19 MV/m
Temp(avg)= 2.00 K
Qo(max)= 1.10E+10
pi mode
limitation: PWR
TM010
x rays start at 15.5 MV/m, still Q disease seen
Xray / Q 18.26 106724
Surface Resistant Analysis
Fowler-Nordheim Analysis
X - Ray
Kurve-QvsE6_X-Ray.vi

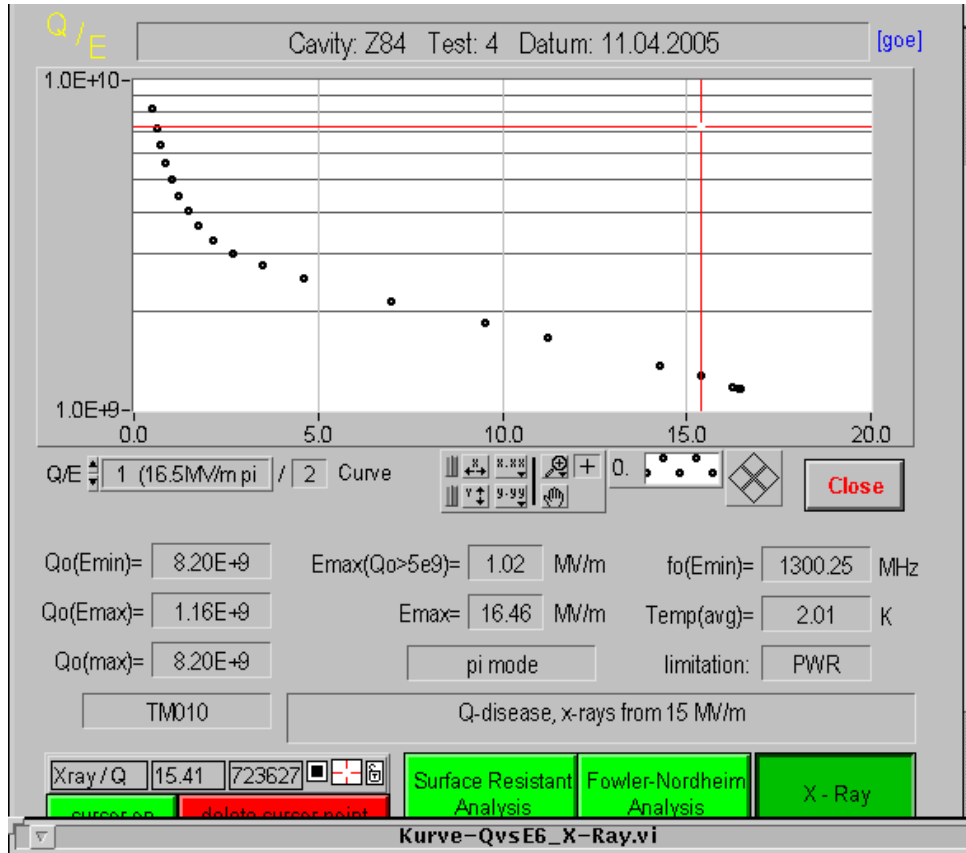
Q / E
Cavity: Z84 Test: 4 Datum: 11.04.2005
[goe]
1.0E+10
1.0E+9
0.0
5.0
10.0
15.0
20.0
Q/E 1 (16.5MV/m pi / 2 Curve
Close
Qo(Emin)= 8.20E+9
Emax(Qo>5e9)= 1.02 MV/m
fo(Emin)= 1300.25 MHz
Qo(Emax)= 1.16E+9
Emax= 16.46 MV/m
Temp(avg)= 2.01 K
Qo(max)= 8.20E+9
pi mode
limitation: PWR
TM010
Q-disease, x-rays from 15 MV/m
Xray / Q 15.41 723627
Surface Resistant Analysis
Fowler-Nordheim Analysis
X - Ray
Kurve-QvsE6_X-Ray.vi

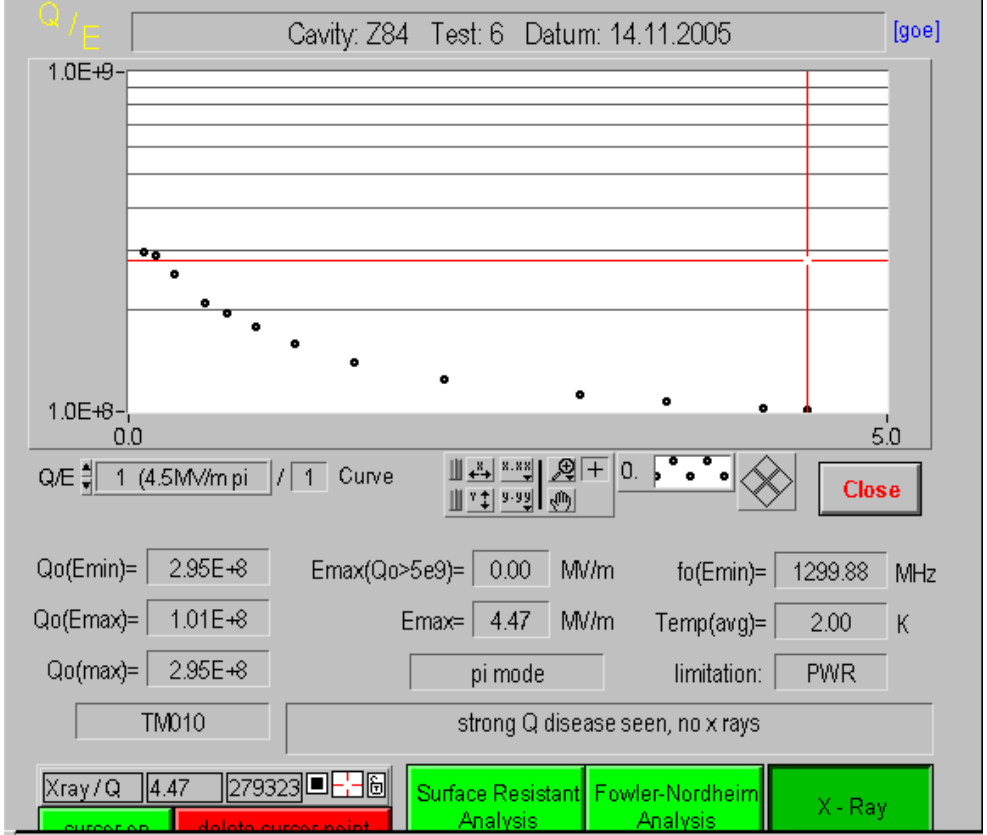
Q / E
Cavity: Z84 Test: 6 Datum: 14.11.2005
[goe]
1.0E+9
1.0E+8
0.0
5.0
Q/E
1 (4.5MV/m pi
/ 1 Curve
0.
Close
Qo(Emin)= 2.95E+8
Emax(Qo>5e9)= 0.00 MV/m
fo(Emin)= 1299.88 MHz
Qo(Emax)= 1.01E+8
Emax= 4.47 MV/m
Temp(avg)= 2.00 K
Qo(max)= 2.95E+8
pi mode
limitation: PWR
TM010
strong Q disease seen, no x rays
Xray / Q
4.47
279323
Surface Resistant Analysis
Fowler-Nordheim Analysis
X - Ray
Kurve-QvsE6_X-Ray.vi
X-Ray / E
Cavity: Z84 Test: 6 Datum: 14.11.2005
[goe]
1.00E+0
1.00E-1
1.00E-2
1.00E-3
1.00E-4
1.00E-5
1.00E-6
0.0
5.0
Xray
4.47
0.00
0.
Close
[mGy/min] / [MV/m]
X-Ray onset = 4E-4 mGy/min

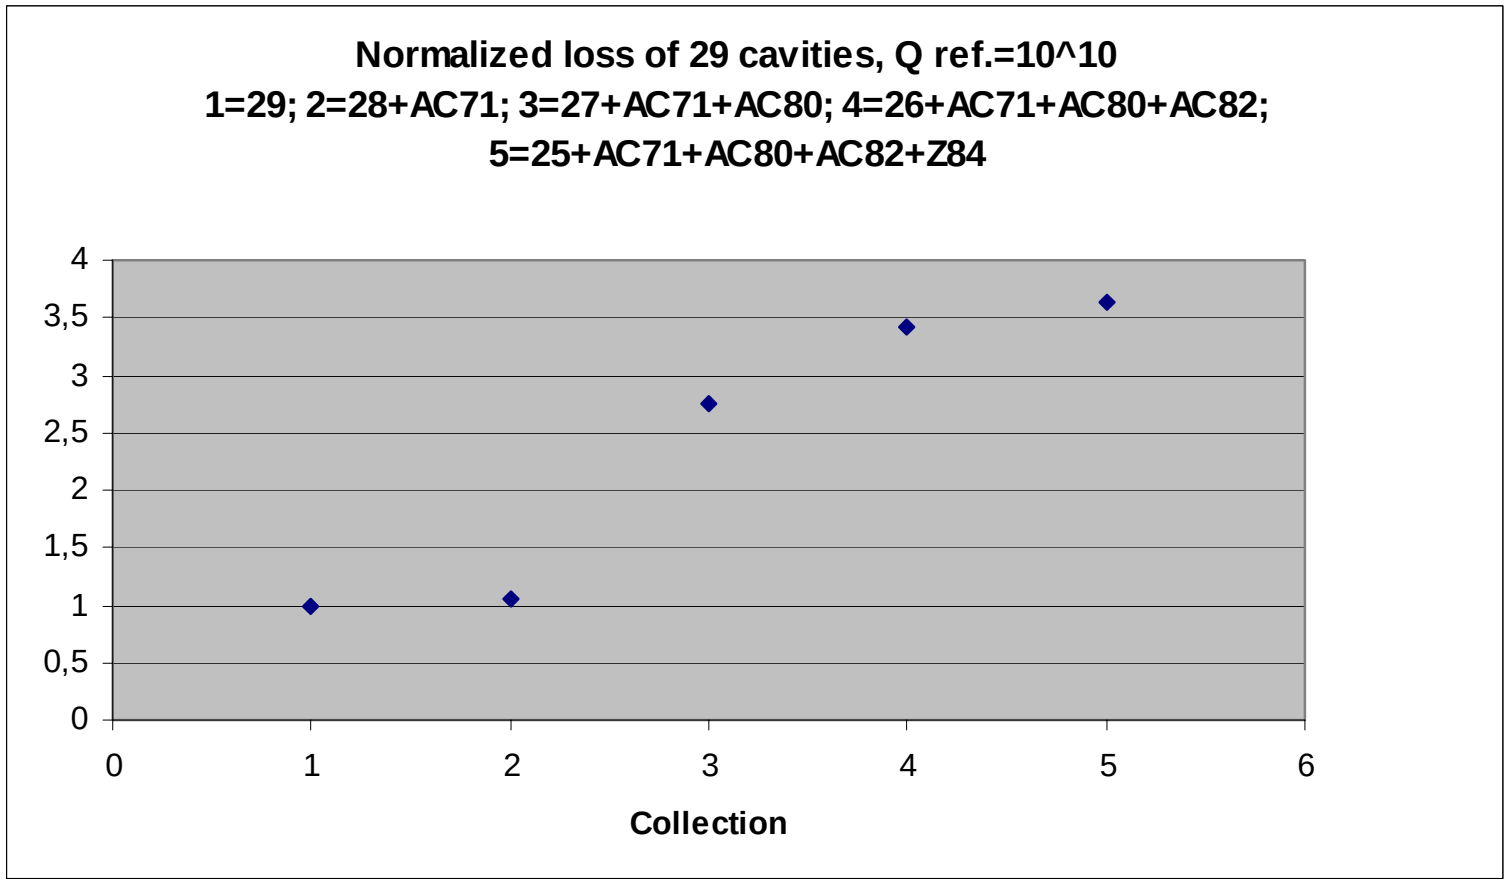
Normalized loss of 29 cavities, Q ref.=10^10
1=29; 2=28+AC71; 3=27+AC71+AC80; 4=26+AC71+AC80+AC82;
5=25+AC71+AC80+AC82+Z84
4
3,5
3
2,5
2
1,5
1
0,5
0
0
1
2
3
4
5
6
Collection

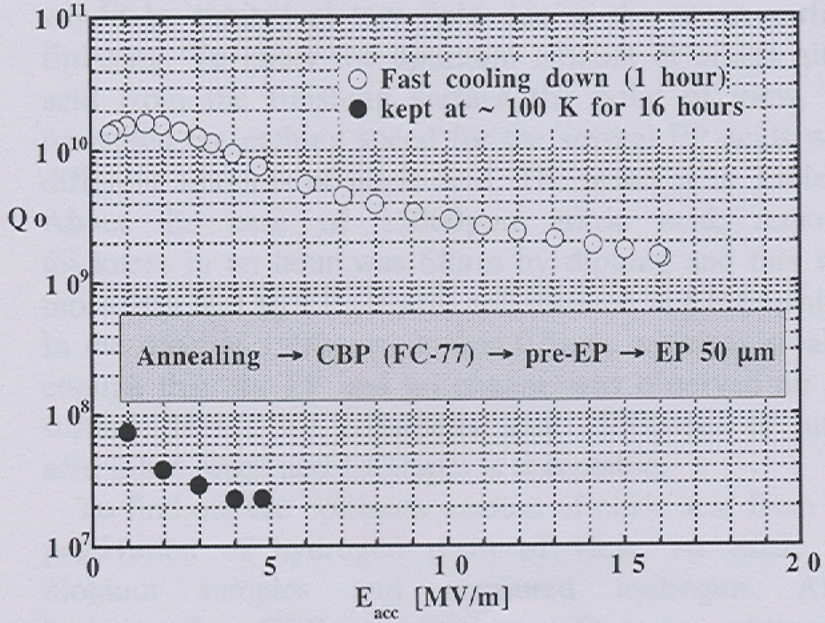
Figure 4: Heavy hydrogen Q-disease did occur when hydrogen-free CBP and EP were combined

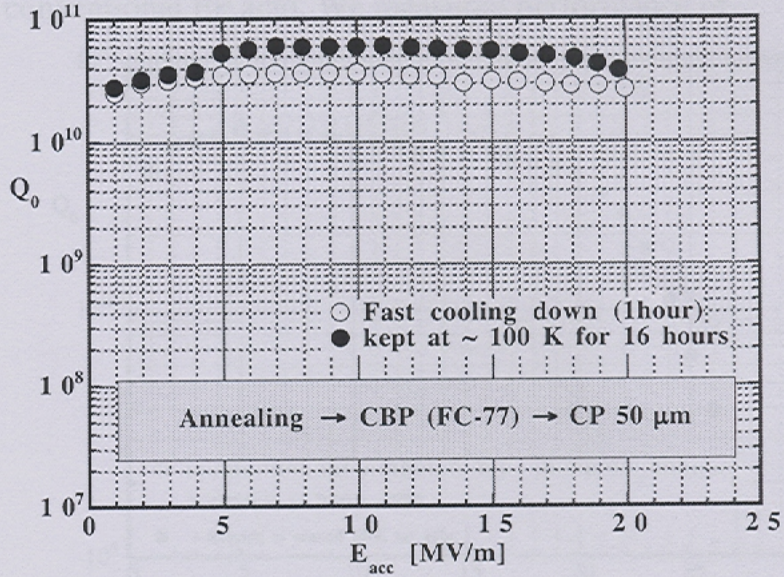
Figure 6: Hydrogen Q-disease did not occur with combination of hydrogen-free CBP and CP

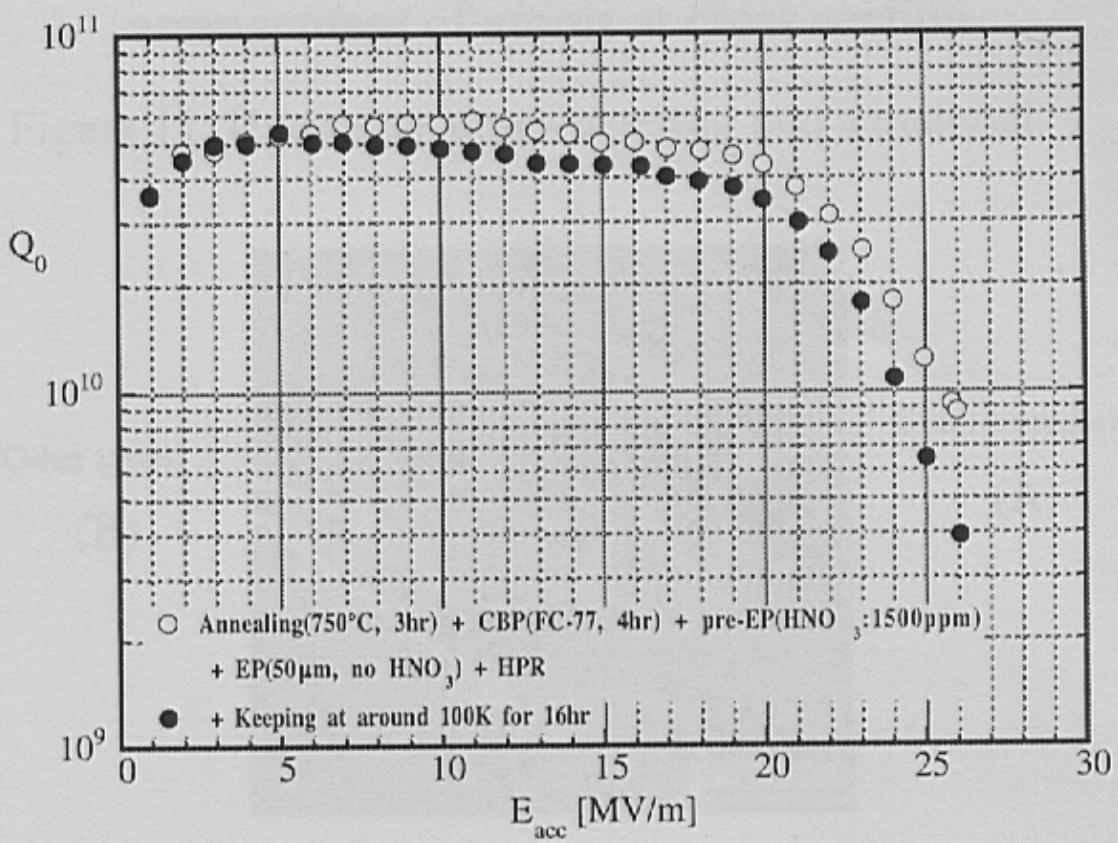
Figure 8: No hydrogen Q-disease resulted for combination of H-free CBP and oxidizer added EP

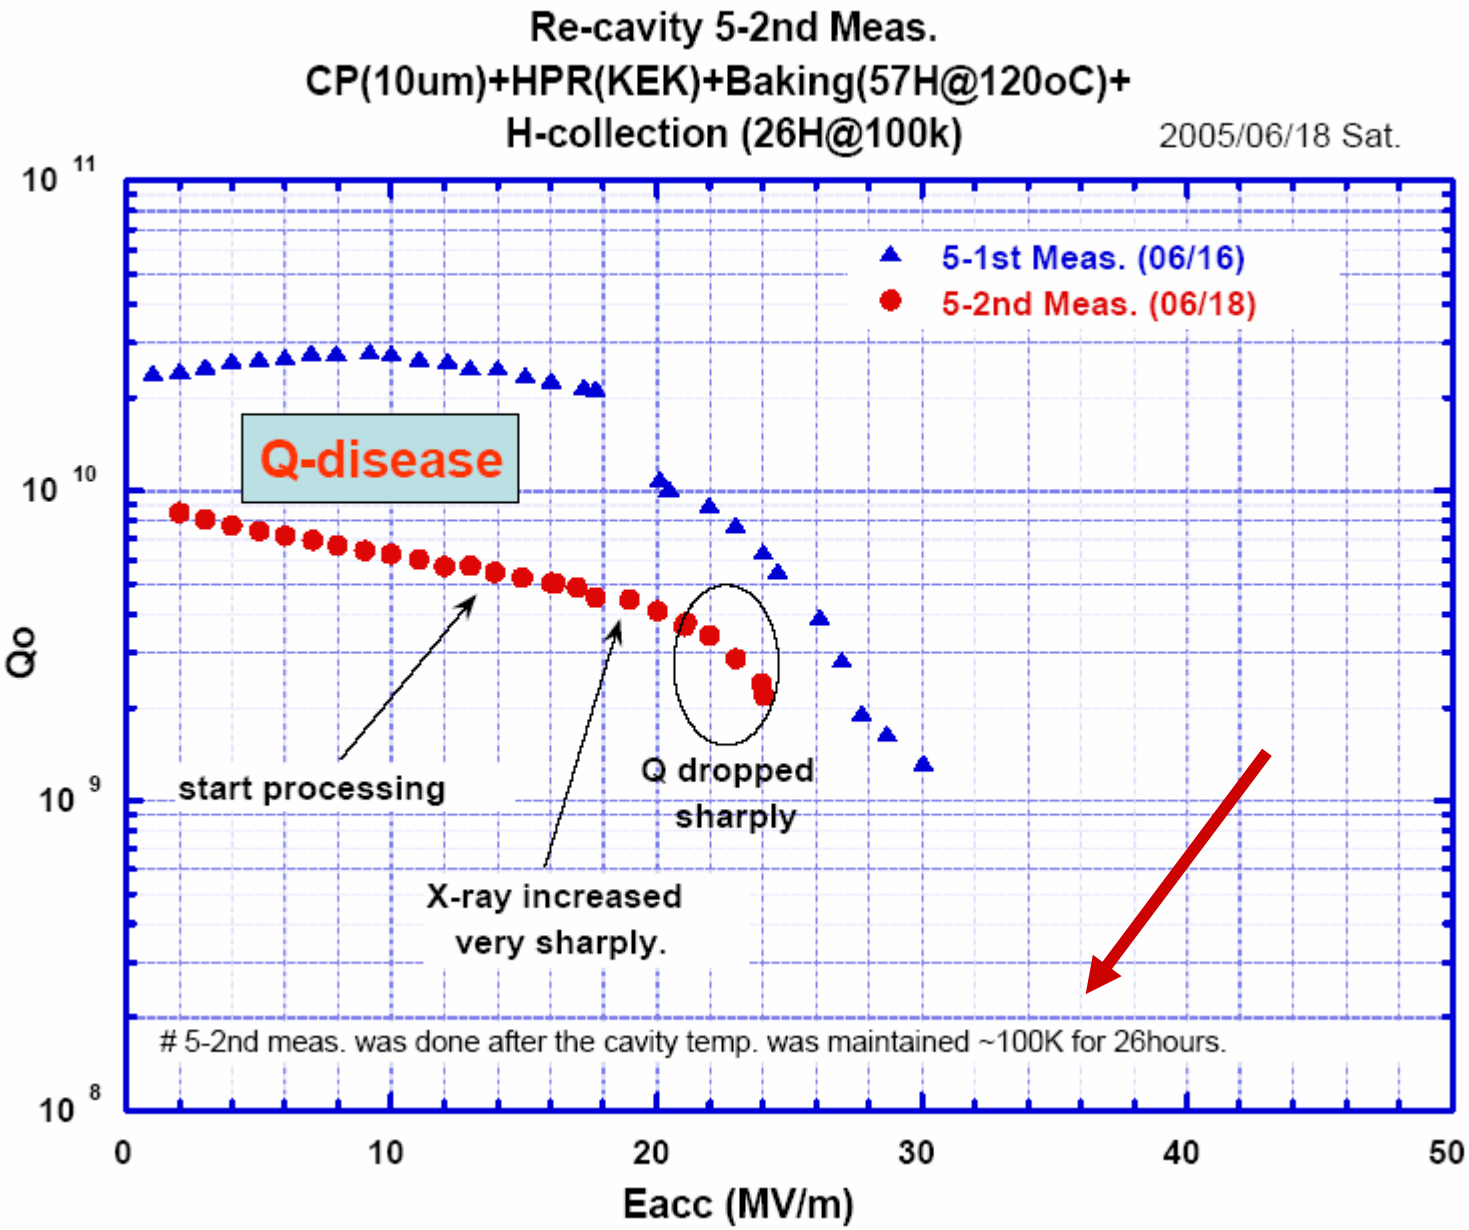
Re-cavity 5-2nd Meas.
CP(10um)+HPR(KEK)+Baking(57H@120oC)+
H-collection (26H@100k)
2005/06/18 Sat.
5-1st Meas. (06/16)
5-2nd Meas. (06/18)
Q-disease
start processing
X-ray increased
very sharply.
Q dropped
sharply
5-2nd meas. was done after the cavity temp. was maintained ~100K for 26hours.
Qo
Eacc (MV/m)
10 11
10 10
10 9
10 8
0
10
20
30
40
50

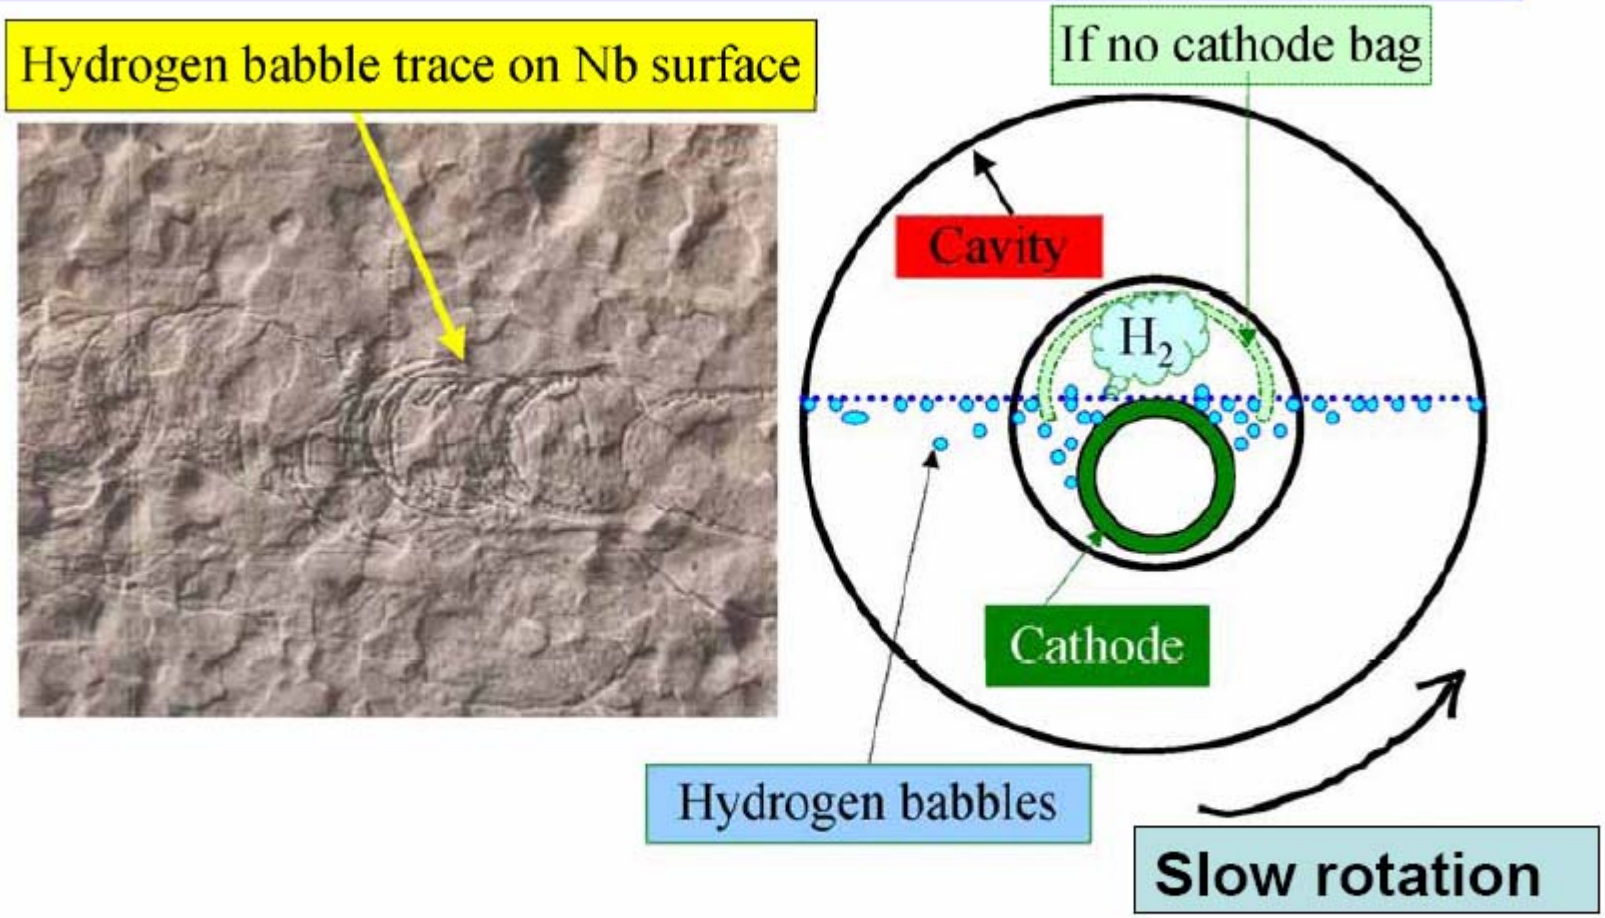
Cathode Bag

Cathode bag was not setup properly by operator

=> Hydrogen Q-disease

- Check-list of all setups and parameters are prepared.
- Re-training operators.

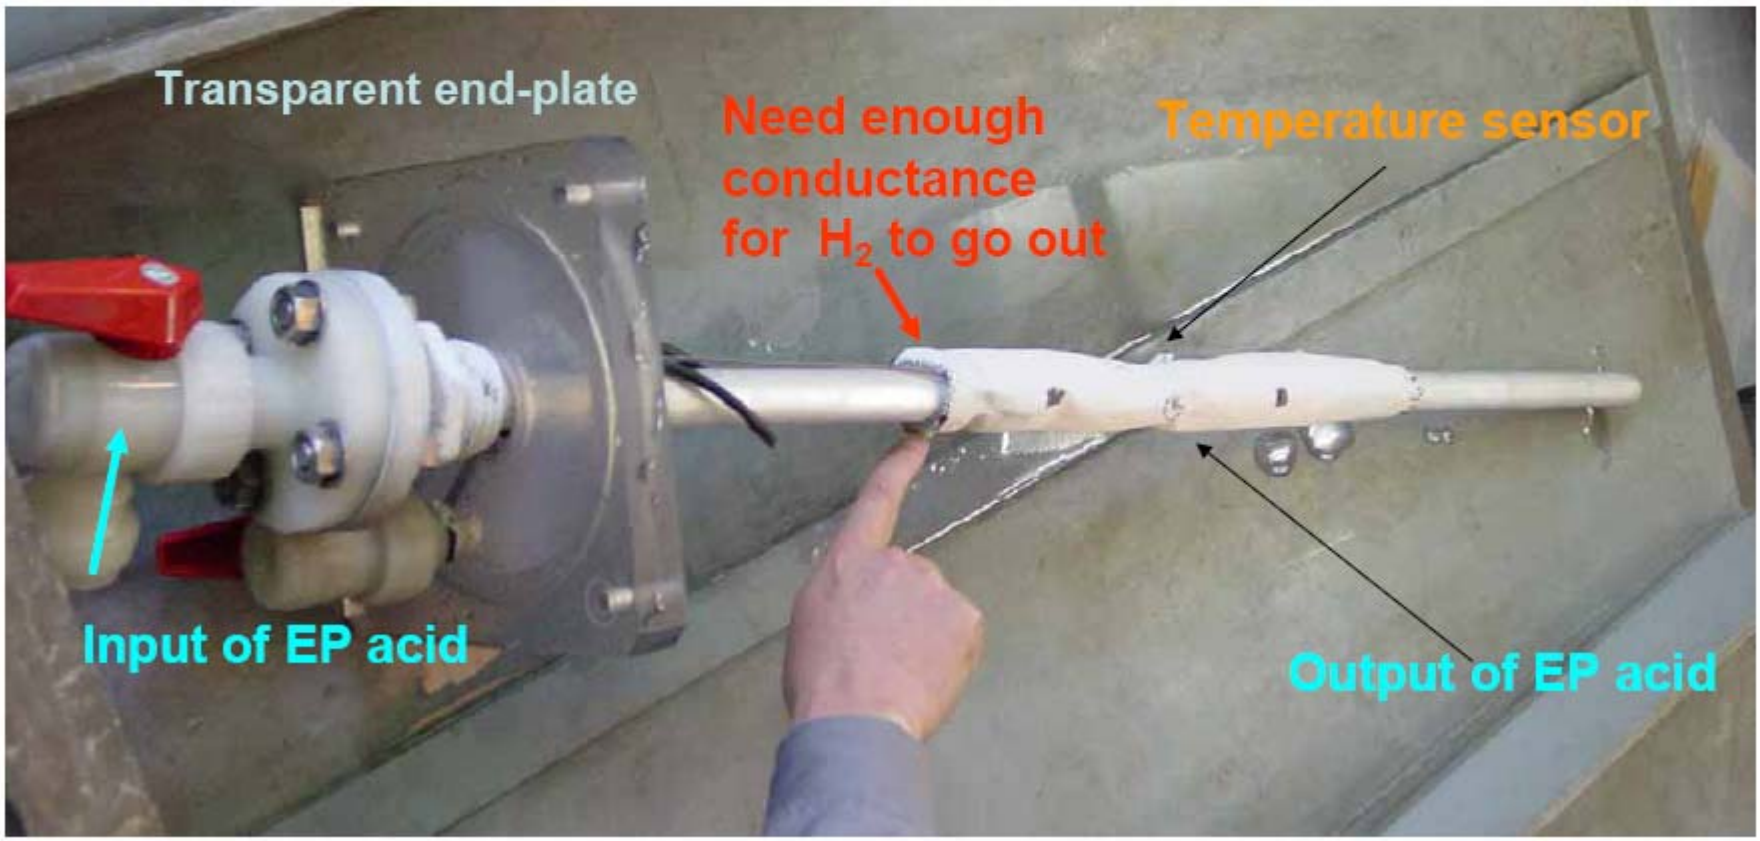
EP acid level control failure

EP acid output valves for level control

EP acid output valve was not properly controlled.

Hydrogen Q-disease

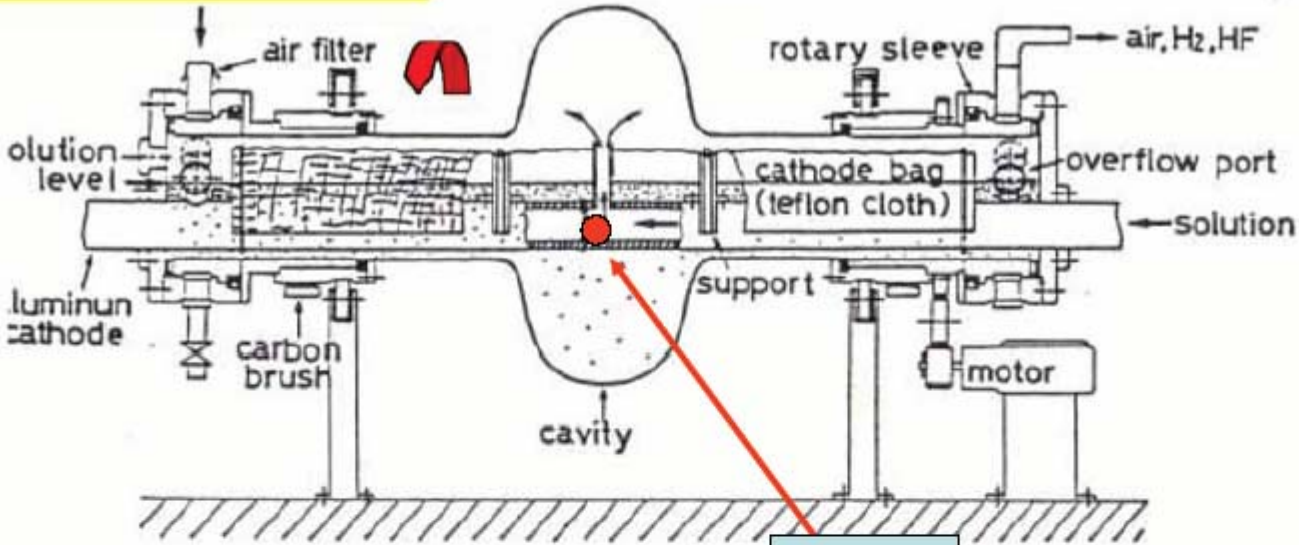
EP acid temperature monitor
& control were not done properly.

Related parameters:
Voltage, Current, EP acid flow,
Reservoir tank temperature.
⇒**Operator forgot how to optimize these parameter-set.**

- Future plan: Automatic monitoring, temp./valve-control by computer. But not easy for EP system parts (Teflon flow-meter, valve…expensive to replace with computer-controllable parts).
